**Flood Control Project Maintenance  
Levee Inspections**

**Maintenance Issue Types Only, Levee Inspection Report By Mile - Fall 2018**

**Reclamation District No. 0563 Tyler Island**

Waterway	Bank	Unit Miles	Inspection Start/End	Inspector
Unit No. 01 Georgiana Slough (Tyler Island)	Left	12.11	10/11/2018 10/11/2018	David Julian

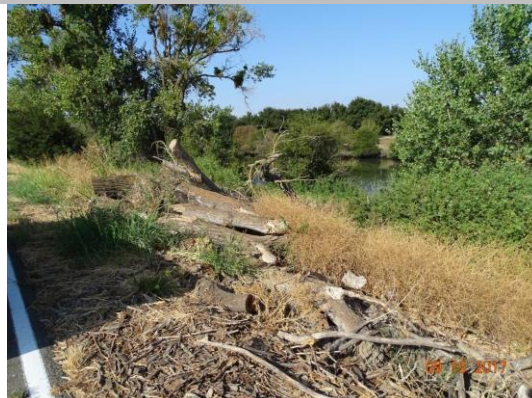
Photo 1 of 1 : FA\_2018\_RD0563\_210\_114\_20180925\_00074.jpg

LM Start	0.40	Rating **	M	Issue No.	114
LM End	0.40	Issue Type +	Ma	Location *	WS
Category	Earthen Levee			GPS Latitude/Longitude	
				Start	End
Item	Encroachments			38.230744 °	38.230744 °
				-121.522022 °	-121.522022 °
DWR ID	DWR_RD0563_01_f_2017_114				
Comment Code					
TR : Tree or limb					
Inspector Comment

Looking southwest at the waterside slope.

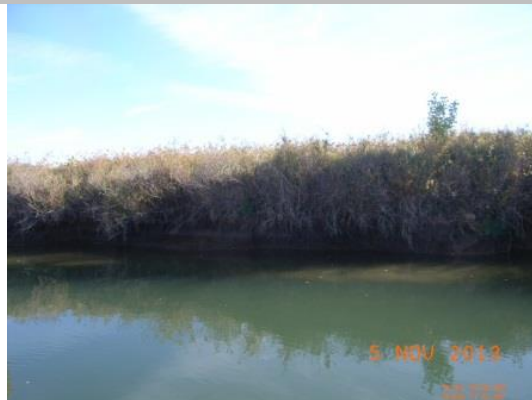
Photo 1 of 1 : FA\_2018\_RD0563\_210\_92\_20181023\_00234.jpg

LM Start	4.98	Rating **	M	Issue No.	92
LM End	5.04	Issue Type +	Ma	Location *	WS
Category	Supplemental			GPS Latitude/Longitude	
				Start	End
Item	2017 USACE Erosion Survey, DRAFT			38.190073 °	38.189524 °
				-121.556307 °	-121.557227 °
DWR ID	DWR_RD0563_01_f_2018_92				
Comment Code					
Inspector Comment					
2017 Site ID: GEO 7.2 L Status: Eroding 2017 Field Notes: New erosion at toe. Site History: 2009 - Small scallops of erosion into the levee toe behind brush boxes. 2011 - Minor new erosion. 2012 - Site extended upstream to account for addition erosion pockets. 2016 - Fresh erosion observed.

USACE 2013 Photo #1

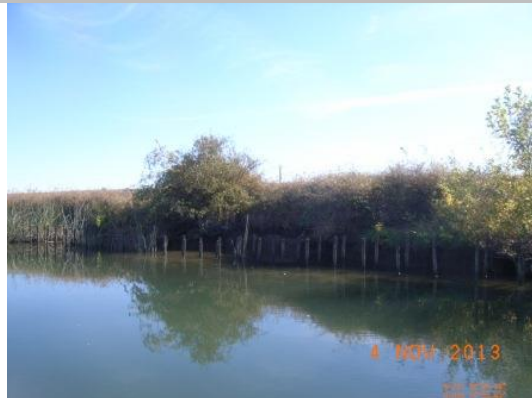
Photo 1 of 1 : FA\_2018\_RD0563\_210\_91\_20181023\_00233.jpg

LM Start	5.39	Rating **	U	Issue No.	91
LM End	5.39	Issue Type +	Ma	Location *	WS
Category	Supplemental			GPS Latitude/Longitude	
				Start	End
Item	2017 USACE Erosion Survey, DRAFT			38.186013 °	38.185968 °
				-121.561512 °	-121.561667 °
DWR ID	DWR_RD0563_01_f _ 2018_91

Comment Code					
Inspector Comment					
2017 Site ID: GEO 6.3 L					
Status: Critical					
2018: Do not see evidence of vertical face erosion from levee hinge. I do not see how this could be rated critical (Djulian).					
2017 Field Notes: Upgraded to CRITICAL. Combined with 6.8. Vertical sections from mid slope to toe, vertical face from levee hinge at some locations. Wave/tide erosion at toe, evidence of beavers.					
Site History: 1997 - Deep pockets of erosion and narrow berm. Reach is characterized by lots of pockets into the existing berm and/or levee slope. 1999 - Some pockets filled with rock riprap. 2000 - Exposed fabric. 2001 - Staked, low fascine walls at bankline. 2002 - New spot of rock at upstream end. Some new brush boxes. 2005 - Some stone sliding off the underlying geotextile fabric. Some new brush bundles in the brush boxes; some with missing bundles. Some boxes too low relative to high tide. 2009 - Minimal new erosion, site length extended. 2010 - New erosion on downstream end, site extended downstream. 2011 - Sites 6.1. 6.4 and 6.6 were combined. New erosion pockets, site extended to include the erosion in between the old sites. 2012 - Rock has been placed in portions of the bank since last year. 2016 - Site 5.8 was merged with this site due to new erosion connecting the sites.

USACE 2013 Photo #1

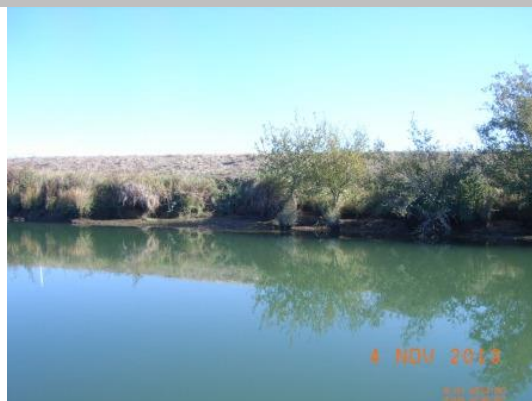
Photo 1 of 1 : FA\_2018\_RD0563\_210\_89\_20181023\_00232.jpg

Comment Code					
Inspector Comment					
2017 Site ID: GEO 5.3 L					
Status: Eroding					
2017 Field Notes: Site extended upstream, increased toe erosion from boat wake/tide action, RD has placed rock on levee slope in places.					
Site History: 1997 - Pocket erosion into the toe of the levee. 2000 - Scallops in banks with small colored flags, biotech rolls present. 2001 - Staked, low fascine walls at bankline. 2003 - Still have visibly bad spots, especially at the upstream end. 2005 - Some new brush bundles in the brush boxes; some with missing bundles. Some boxes too low relative to high tide. 2010 - Site extended upstream. 2011 - Minor new erosion. 2016 - Fresh erosion observed.

USACE 2013 Photo #1

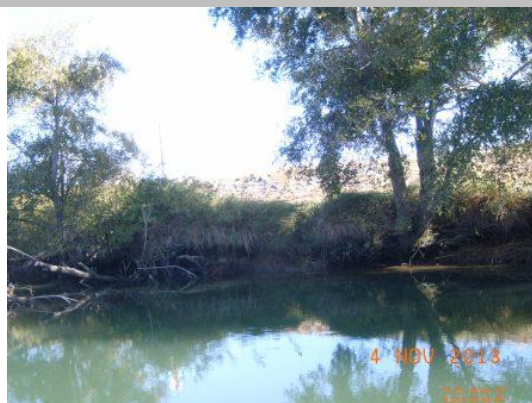
Photo 1 of 1 : FA\_2018\_RD0563\_210\_85\_20181023\_00231.jpg

Comment Code					
Inspector Comment					
2017 Site ID: GEO 4.5 L					
Status: Critical					
2018: Erosion happening at berm, 15 to 20' from the levee hinge point from the berm in some places, erosion into levee toe at other spots (Djulian).					
2017 Field Notes: Numerous areas of bank erosion, with vertical sections up to the levee hinge.					
Site History: 1997 - Pocket erosion at upstream end and into the levee toe under the Alder trees. 2003 - New brush boxes with wattles on bank. 2004 - No brush boxes. 2005 - Site extended from the downstream side of the bridge. Whole bank is vertical. 2010 - Some minor new erosion. 2011 - Site upgraded to CRITICAL. New erosion pockets throughout the site. Sites 4.5, and 4.6 were combined. 2016 - Fresh erosion observed.

USACE 2013 Photo #1

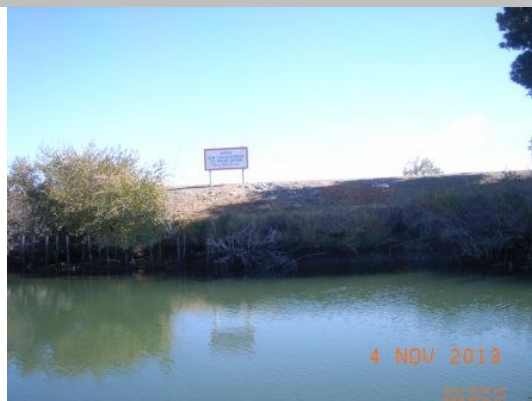
Photo 1 of 1 : FA\_2018\_RD0563\_210\_84\_20181023\_00230.jpg

Comment Code					
Inspector Comment					
2017 Site ID: GEO 4.3 L					
Status: Eroding					
2017 Field Notes: The worst sections have been filled with quarry stone , but still areas of concern.					
Site History: 1997 - Pockets of erosion into the levee toe. 1999 - Minor rock riprap and willow bundles place in a couple of spots. 2001 - Staked, low fascine walls at bankline. 2003 - Small unprotected pockets still eroding. 2004 - Numerous brush boxes, some falling apart, some with new bundles. 2005 - Some new brush boxes installed; some boxes are empty. Levee slope and banks still look bad with pocket scallops into the levee slopes. 2011 - Erosion continues and the number of pockets is increasing. 2013 - Some of the downstream end was repaired by the RD. 2016 - Fresh erosion observed.

USACE 2013 Photo #1

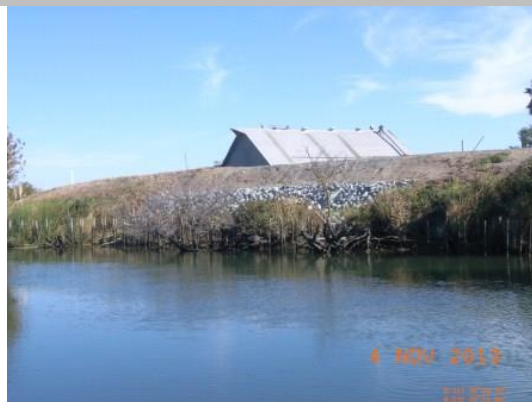
Photo 1 of 1 : FA\_2018\_RD0563\_210\_83\_20181023\_00229.jpg

LM Start	8.12	Rating **	M	Issue No.	83
LM End	8.59	Issue Type +	Ma	Location *	WS
Category	Supplemental			GPS Latitude/Longitude	
				Start	End
Item	2017 USACE Erosion Survey, DRAFT			38.156987 °	38.152919 °
				-121.587427 °	-121.591129 °
DWR ID	DWR_RD0563_01_f_2018_83

Comment Code					
Inspector Comment					
2017 Site ID: GEO 3.8 L					
Status: Eroding					
2017 Field Notes: Fresh toe erosion, significant undercutting and slumping.					
Site History: 1997 - Pockets of erosion into the levee at the water line. Alders are being undercut and rotating out into the channel. Damaged rock at upstream end. 2000 - New minor erosion. 2001 - Staked low fascine walls at bankline. 2002 - New "Brush Boxes" along the bank toe. 2003 - New erosion pockets in the middle of the site. 2005 - Some new bundles in the brush boxes. 2011 - Site upgraded to CRITICAL. Significant new erosion. Sites 3.6, 3.7, 3.71, and 4.0 were combined. 2012 - Rock has been placed in some of the erosion pockets since last year, however site remains critical. 2013 - Site no longer critical. The worst pockets were filled with rock by the local RD.

USACE 2013 Photo #1

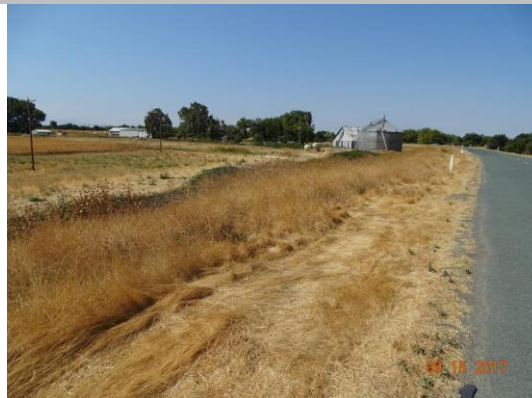
Photo 1 of 1 : FA\_2018\_RD0563\_210\_767\_20180925\_00115.jpg

LM Start	8.18	Rating **	U	Issue No.	767
LM End	8.22	Issue Type +	Ma	Location *	LS
Category	Earthen Levee			GPS Latitude/Longitude	
				Start	End
Item	Vegetation			38.156878 °	38.156945 °
				-121.588505 °	-121.589258 °
DWR ID	DWR_RD0563_01_s_2015_767				
Comment Code					
V2 : Remove the wild growth other than native grasses from the levee slopes.					
Inspector Comment					
Dead dense vegetation blocking landside toe.

Looking south at the landside slope.

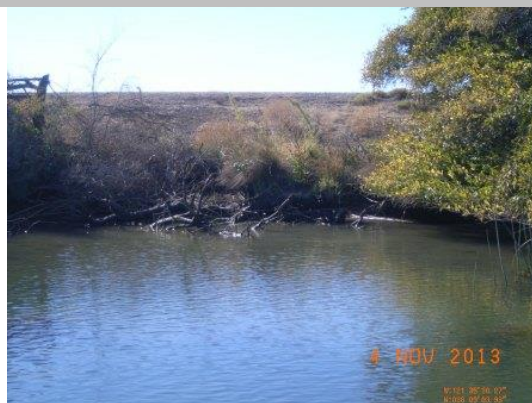
Photo 1 of 1 : FA\_2018\_RD0563\_210\_82\_20181023\_00228.jpg

LM Start	9.73	Rating **	A/W	Issue No.	82
LM End	9.90	Issue Type +	Ma	Location *	WS
Category	Supplemental			GPS Latitude/Longitude	
				Start	End
Item	2017 USACE Erosion Survey, DRAFT			38.150820 °	38.150647 °
				-121.593650 °	-121.596858 °
DWR ID	DWR_RD0563_01_f_2018_82				
Comment Code					
Inspector Comment					
2017 Site ID: GEO 2.5 L					
Status: Eroding					
2017 Field Notes: Head scarp observed.					
Site History: 1997 - Erosion pockets into the toe of the levee. 2001 - Staked low fascine walls at the bankline. 2004 - Numerous "Brush Boxes." 2005 - Some new bundles in the brush boxes. 2012 - Site extended downstream to account for new bank sloughing. 2013 - Some rock added to the upstream end by the local RD.

USACE 2013 Photo #1

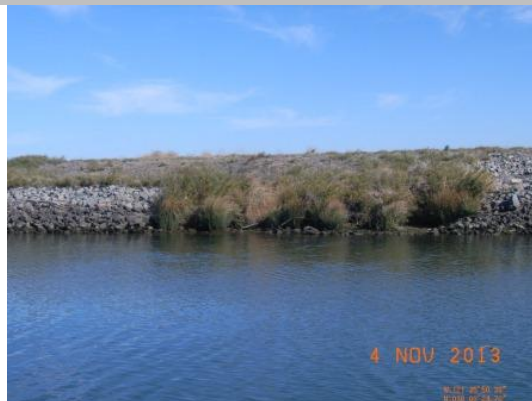
Photo 1 of 1 : FA\_2018\_RD0563\_210\_65\_20181023\_00111.jpg

LM Start	10.45	Rating **	M	Issue No.	65
LM End	10.74	Issue Type +	Ma	Location *	WS
Category	Supplemental			GPS Latitude/Longitude	
				Start	End
Item	2017 USACE Erosion Survey, DRAFT			38.143519°	38.139918°
				-121.599677°	-121.596986°
DWR ID	DWR_RD0563_01_f_2018_65				
Comment Code					
Inspector Comment					
2017 Site ID: GEO 1.7 L Status: Eroding 2017 Field Notes: New rock placed in erosion pockets , site has improved with work done by RD, but still some erosion pockets and toe erosion. Slump failure with headscarp at downstream end. Site History: 1997 - Old damaged rock riprap along the toe. 1999 - Downstream end (400 ft) repaired with rock. 2002 - New rock/concrete rubble section on the downstream end. 2004 - Small pocket repairs at the downstream end. 2005 - Some new bundles in the brush boxes. 2012 - Some rock has been placed in last year.

USACE 2013 Photo #1

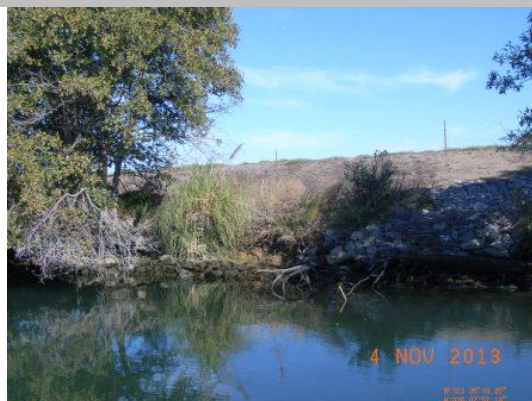
Photo 1 of 1 : FA\_2018\_RD0563\_210\_63\_20181023\_00093.jpg

2017 Site ID: GEO 0.3 L  
Status: Eroding  
2017 Field Notes: Site shortened. New rock placed on levee slope in erosion pockets.  
Site History: 1997 - Erosion pockets into the levee toe. 1999 - Some small pockets fixed with rock riprap. 2002 - New "brush boxes" along the bank toe. 2005 - Brush boxes are empty. Some pockets are filled with new stone. 2006 - Some new rock at the downstream end (~100 ft long). Several small pockets of new rock in scallops. Brush boxes in poor to fair condition. 2010 - Site looks a little worse, some toe rock but still has erosion scars at lower to mid slope. 2011 - Site upgraded to CRITICAL. Significant new erosion. Erosion scallops are vertical and almost the height of the levee. 2012 - Rock has been placed in some of the erosion scallops and therefore the site is no longer critical. 2013 - Site shortened site. The downstream half of site was repaired by RD. Pipe no longer in site limits.

USACE 2013 Photo #1

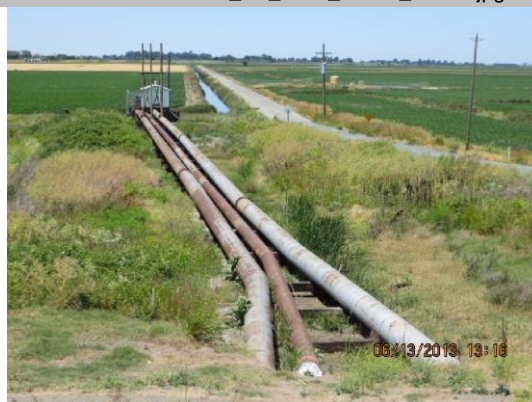
Photo 1 of 3 : UCIP\_FA\_2018\_52771\_24731.jpg

FS\_ID:52771  
DS\_ID:20172  
EP\_NO: 11213  
Repair Type: No Action Needed  
Crossing Status: Found  
UCIP Comments:  
FIELD\_STRUCT\_DESC: 20-inch steel drainage pipe through the levee, 1 foot below the crown. Pump on the landside (LS). Siphon breaker on the waterside (WS) shoulder. (18-inch pipe [HLM 12.28] at a depth of 4-feet authorized under Automatic Board Order (ABO) issued as Permit No. 11213, 1975 - Reclamation District No. 563). [Additional Reference(s): DWR Levee Log, 2005. USACE Sacramento O&M Manual 103, June 1954, (Station ""L"" 6+48.9)].  
FS Date: 7/13/2018

Pump and pipes off LS toe.

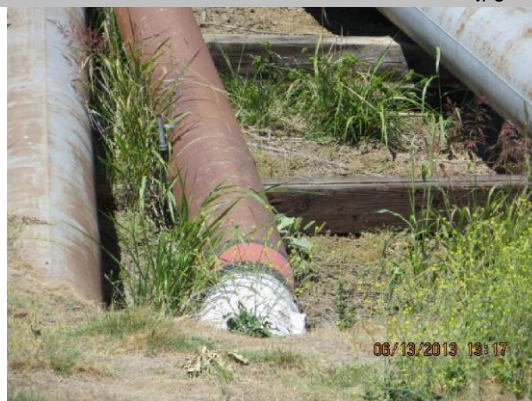
Photo 2 of 3 : UCIP\_FA\_2018\_52771\_24730.jpg

20-inch pipe on LS toe.

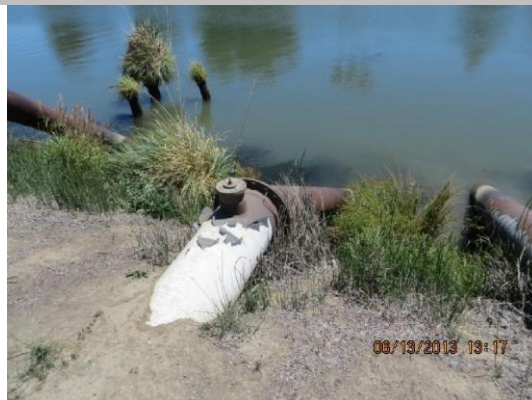
Photo 3 of 3 : UCIP\_FA\_2018\_52771\_24729.jpg

Pipe and siphon breaker on WS shoulder.

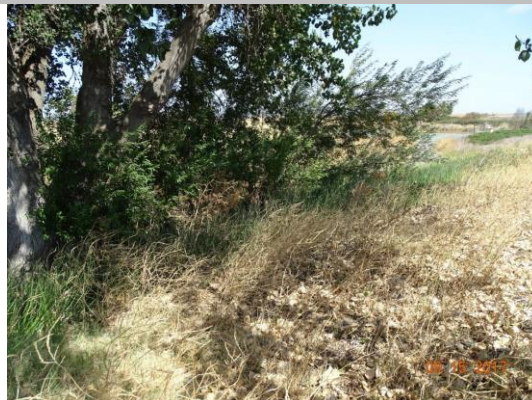
Photo 1 of 2 : FA\_2018\_RD0563\_210\_47\_20180925\_00019.jpg

LM Start	12.04	Rating **	M	Issue No.	47
LM End	12.04	Issue Type +	Ma	Location *	LS
Category	Earthen Levee			GPS Latitude/Longitude	
				Start	End
Item	Trim / Thin Trees			38.130758 °	38.130758 °
				-121.579027 °	-121.579027 °
DWR ID	DWR_RD0563_01_s_2012_47				
Comment Code					
T1 : Trim trees to at least five feet above ground level.					
Inspector Comment					
Trim tree on landside slope.

Looking northeast at the landside slope.
